NASA/CR-2002-211757 ICASE Report No. 2002-24

Progressive Failure Studies of Stiffened Panels Subjected to Shear Loading

PROGRESSIVE FAILURE STUDIES OF STIFFENED PANELS SUBJECTED TO SHEAR LOADING

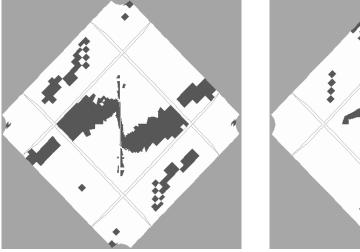
Analytical damage plots for matrix cracking, fiber-matrix shear, and fiber failure are compared in Figure 12 with damage as observed visually. Figures 12(a) through 12(c) show matrix cracking, fiber-matrix shear, and fiber failure damage plots, respectively, in some selected plies within the skin. The dark contours represent damaged areas. Figure 12(d) shows a picture of the panel after failure. The cracks that propagated from the tips of the notch when the panel failed catastrophically can be seen from this figure. The location of the observed cracks match the analytically predicted damaged areas in Figure 12(a) through 12(c) which also originated from the tips of the notch.

FIGURE 12. Comparison of analytical damage plot and observed damage results for notched panel.

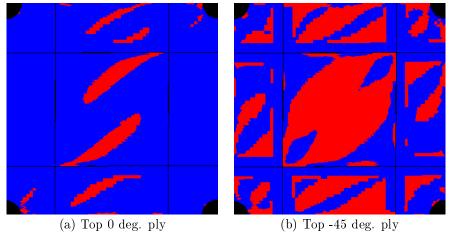
The analysis results suggest that damage first initiates as matrix cracking at the location shown in Figure 16 at a load of 11.32 kips within the bottom -45 and 0 degree plies. As the load is increased, fiber-matrix shear and fiber failure damage initiate, at 25.11 kips and 26.26 kips respectively, at the location shown in Figure 16 within the bottom -45 degree ply. Fringe plot of matrix cracking damage at a load of approximately 30.0 kips (Run-2) in the top 0 and -45 degree plies are shown in Figure 23(a) and Figure 23(b), respectively. The red fringes indicate damage areas. At this load level, analysis results suggest that the fiber-matrix shear and fiber failure damage are still limited to the small area shown in Figure 16.

FIGURE 23. Fringe plot of matrix cracking damage at approximately 30,000 lbs (Run-2) for the un-notched panel.

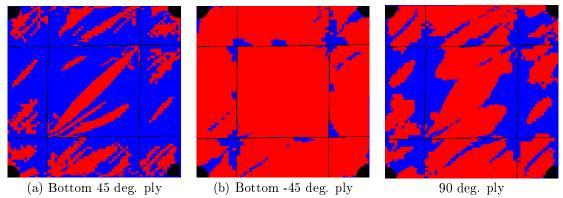
Fringe plots of matrix cracking, fiber-matrix shear, and fiber failure after final failure of the panel are shown in Figure 24 and 25. As shown in Figure 24, the matrix cracking damage in the -45 degree ply is more extensive than in the 45 and 90 degree plies. Fringe plots of fiber-matrix shear and fiber failure damage for the top -45 and 45 degree plies are shown in Figure 25. The fiber failure in the top 45 degree ply as shown in Figure 25(c) is consistent with the visually observed fiber failure damage around the top stiffener intersection in the top right corner as shown in Figure 26(a) and with the fiber failure detected by the thermograph scan as shown in Figure 26(b). These fiber failures contributed to the catastrophic failure of the panel. Analytical fiber failure damage plot shown in Figure 27(a) at a load level of 44.1 kips (just before failure) indicates negligible damage in the top 45 degree ply at the stiffener intersection region as compared to Figure 25(c), which is a plot of fiber failure damage at 40.5 kips after the panel collapsed. This was captured by the digital video camera and is shown in Figures 27(b) and 27(c). There is no visible fiber failure in Figure 27(b) at 44.2 kips whereas in Figure 27(c) there is visible fiber failure damage at the same load level of 44.2 kips at which load the panel failed catastrophically. The yellow region in Figure 26(b) indicates extensive internal damage to the skin. The extensive matrix cracking as shown in Figure 24 for a few selected plies and the fiber-matrix shear and fiber failure damage as shown in Figure 25(a) and 25(b) also suggest existence of panel damage.

FIGURE 24. Fringe plot of matrix cracking damage after failure (Run-3) for the un-notched panel.

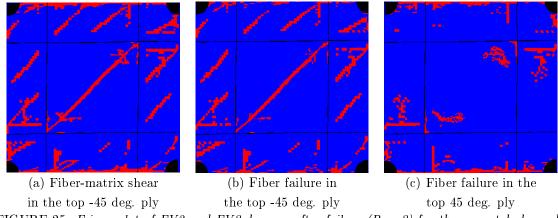
FIGURE 25. Fringe plot of FV2 and FV3 damage after failure (Run-3) for the un-notched panel.

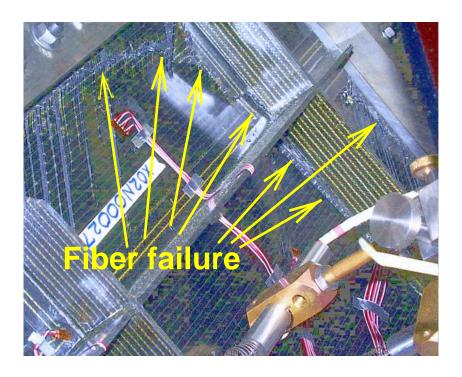
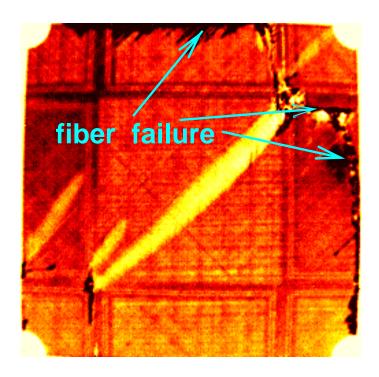
FIGURE 26. Observed damage after final failure of the un-notched panel.

(a) Visual inspection

(b) Thermographic scan

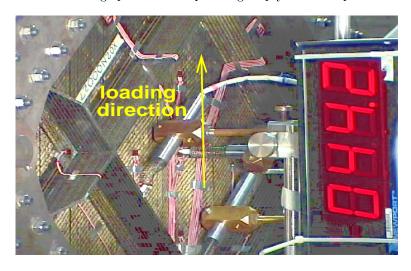
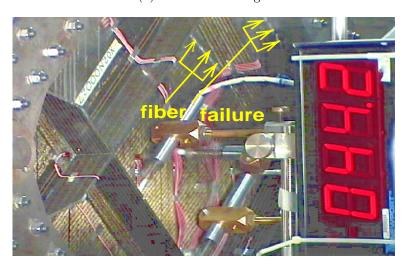
FIGURE 27. Contribution of fiber failure damage to catastrophic failure of the unnotched panel.

The predicted and observed damage modes from the test and analyses were in agreement for the notched panel as well as for the un-notched panel. The progressive failure analyses were able to predict the fiber failure damage mode that led to catastrophic failure of the panels.

(b) No visible damage

(c) Fiber failure damage
